Preliminary Accident Report

Version number: 1.1
Date 10 December 2024

By Ria Moothilal on behalf of SAHPA / SACAA

Reference Number: SAHPA/128/25/03/2024

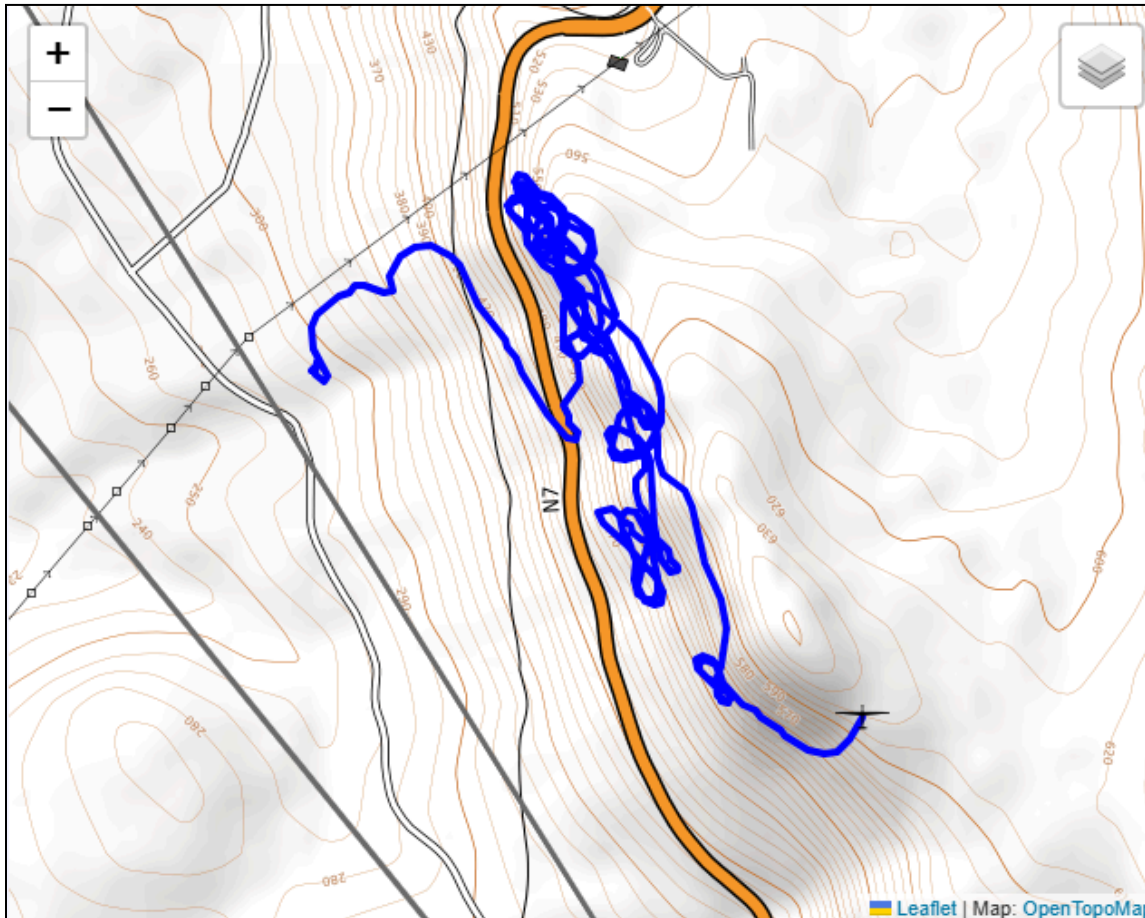
Figure 1: Solo paraglider flight resulting in a fatal accident on the west side of Piekinierskloof Pass (N7) near the town of Eendekuil in the Western Cape

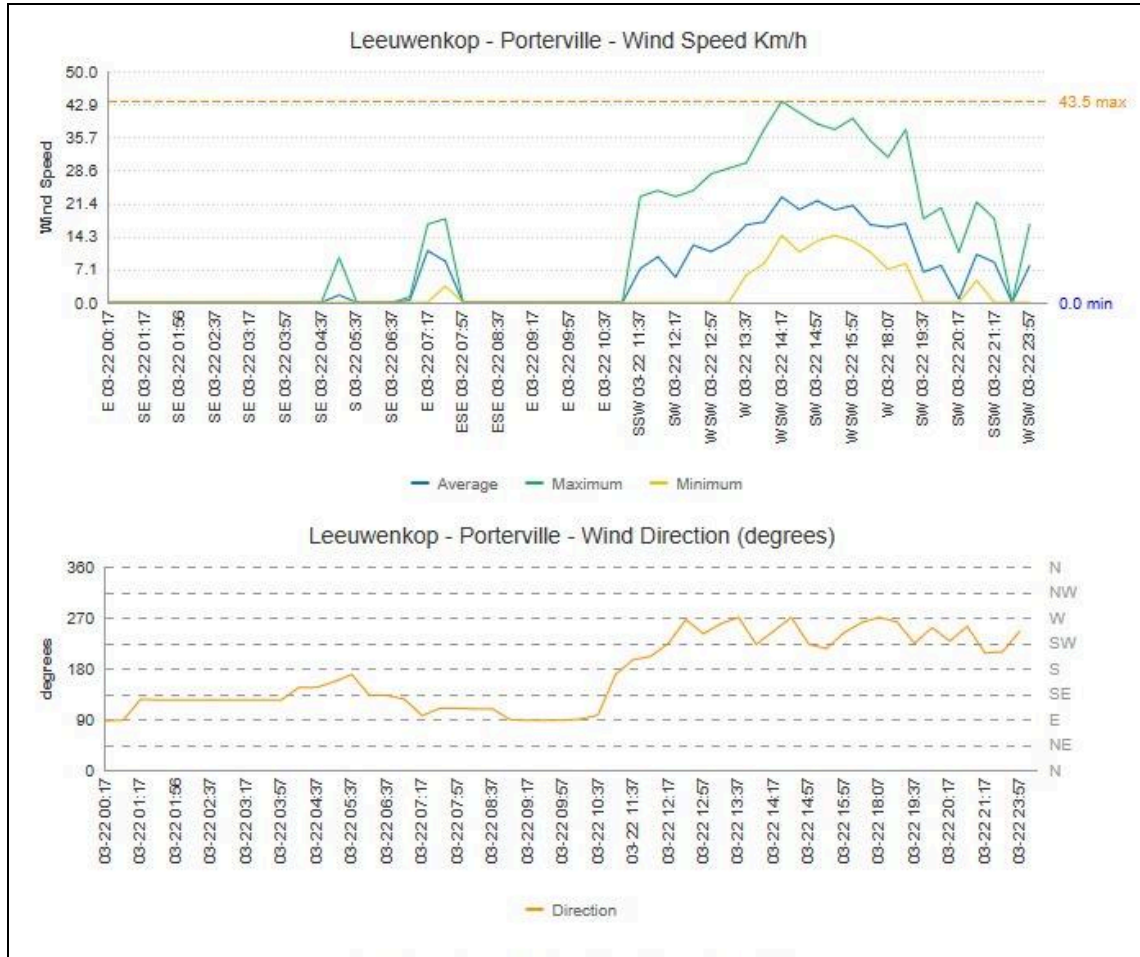
Figure 19: Leuwenkop weather station wind over time

- 1) At ~1 pm the average wind speed was ~14kph from the WSW
- 2) At ~1 pm the maximum wind speed was ~ 29kph
- 3) The wind speed trend shows an increasing trend in strength from ~12h00 to ~14h15 and then a decrease till late at night at ~22h00. The direction in this period varied between W and SW

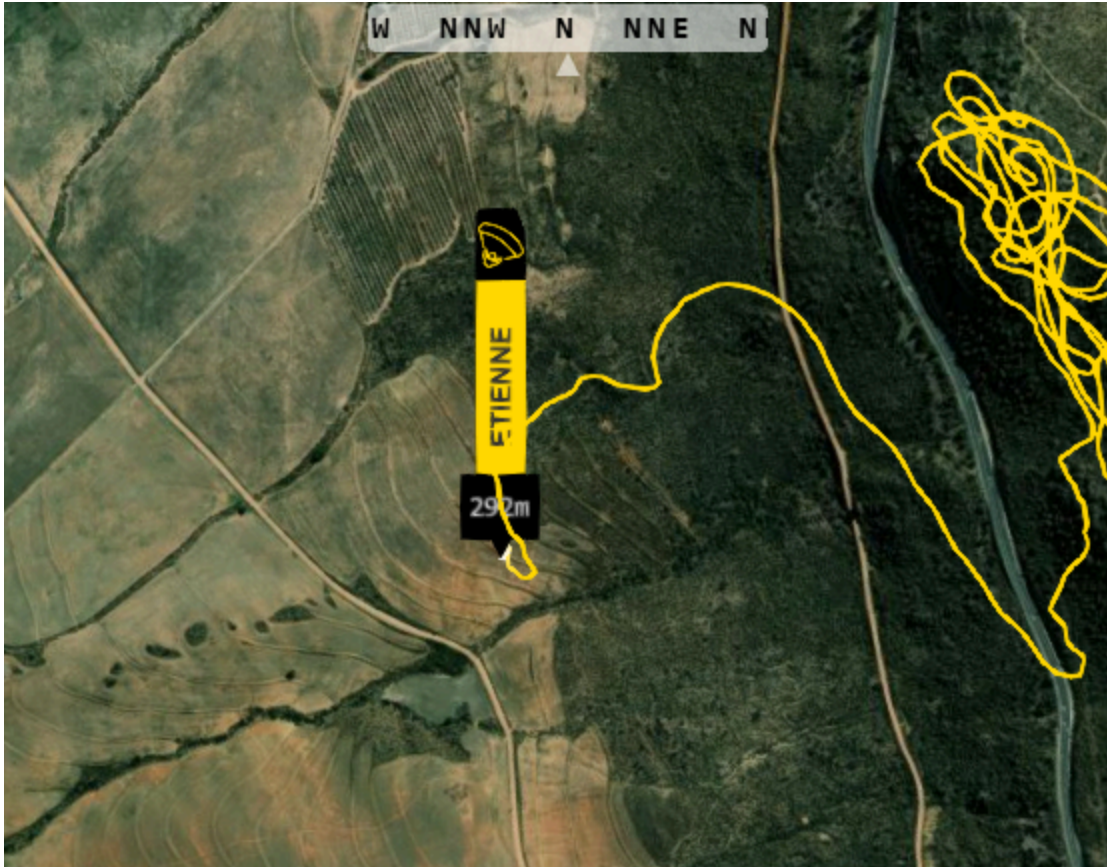
- 1.10.1.3. Towards the end of the flight the pilot flies away from the ridge, then turns to fly on a southerly heading just before the end of the flight

Figure 23: Top view of the last section of the flight

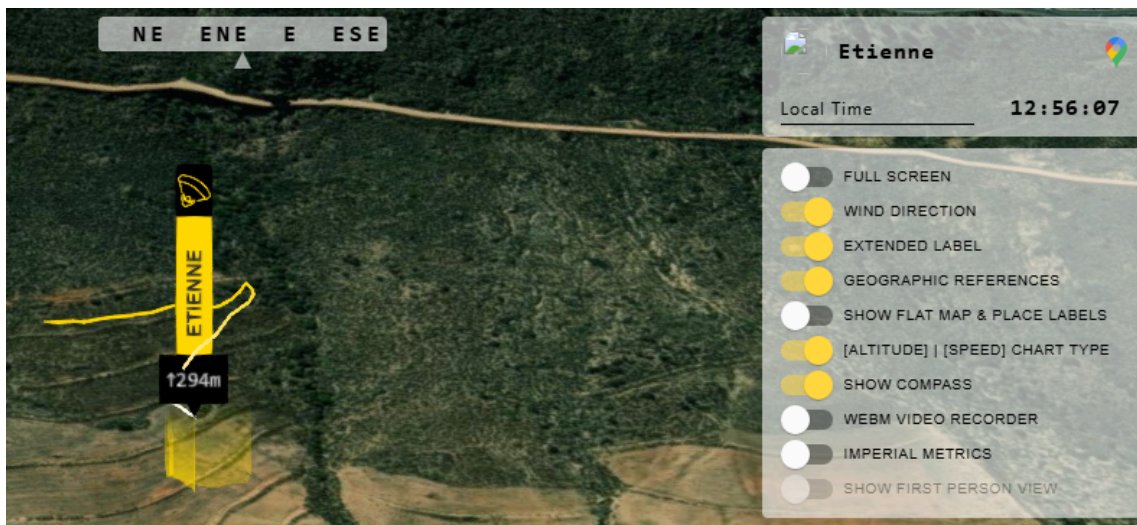
1.10.1.4. The pilot climbs for a few seconds before going into a right turn and rapidly losing altitude until impact.

Figure 24: Side view showing the last section of the track. NB. The end of the track is at ground level - the gap that appears in the screenshot is an image overlay issue with the software used to create this visualisation

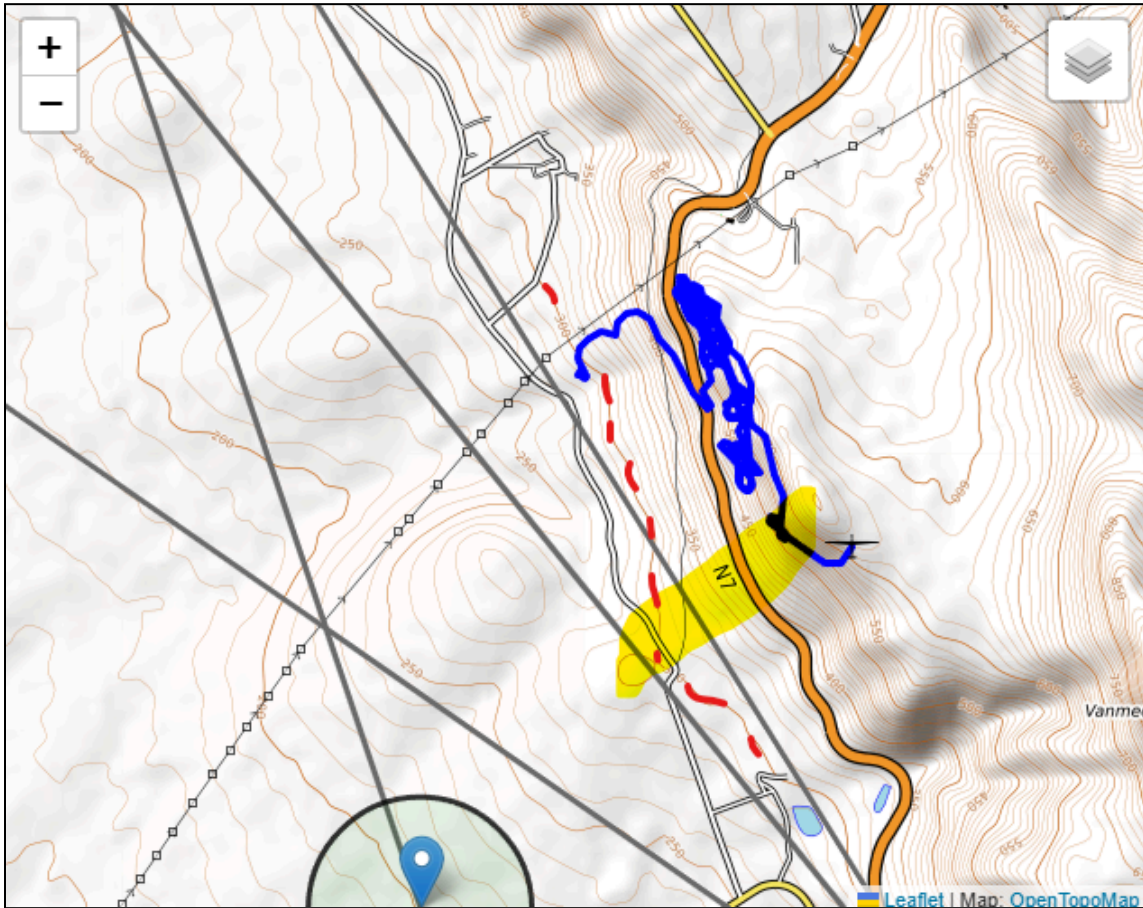
- 1.10.1.5. Topographical analysis shows the presence of a spine upwind of the accident scene. This spine is highlighted in yellow in the snapshot below. The 300m contour interval is highlighted with a red dashed overlay to assist with interpreting the topography.

Figure 25: Topographical features within the vicinity of the flight

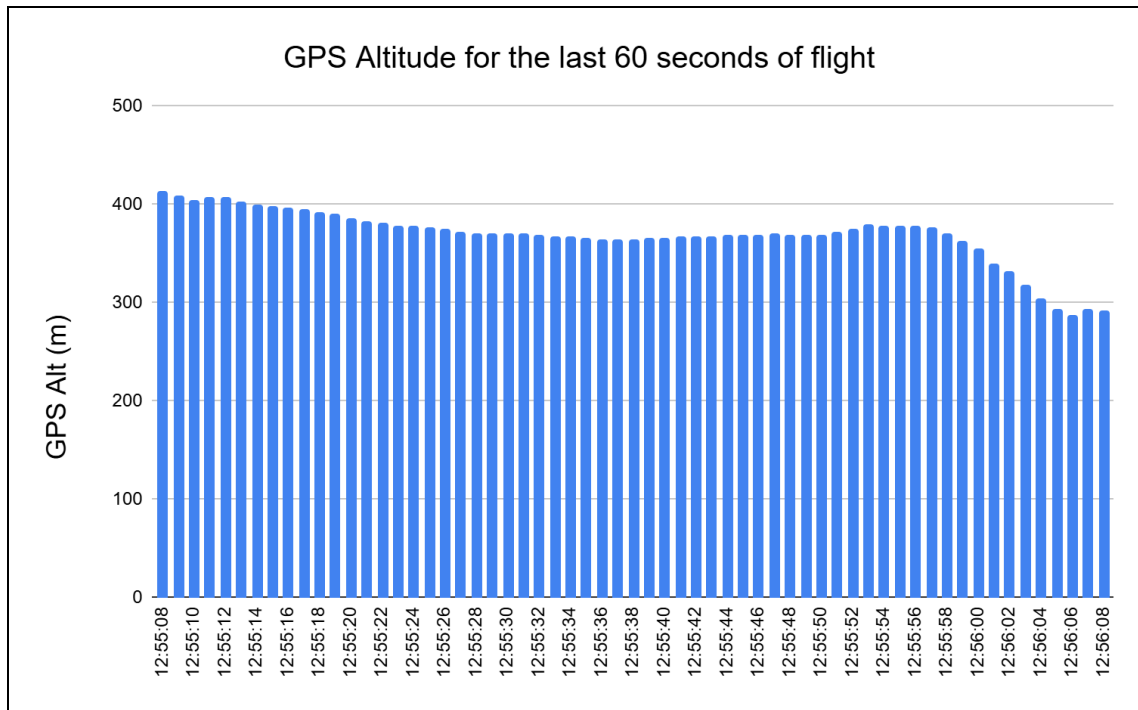
- 1.10.1.6. Analysis of GPS Altitude **for the last 60 seconds of flight**. The significant loss of altitude at the end starts at 12:55:57 when the GPS altitude is 376m ASL and ends at 12:56:08 at 292m ASL. This equates to a loss of 84m over 11 seconds before impact.

Figure 26: Tracklog derives GPS speed for the last 60 seconds of flight
