# Preliminary Accident Report

Date 29 July 2023

By Ria Moothilal on behalf of SAHPA / SACAA

**Reference Number:** SAHPA/103/04/04/2023

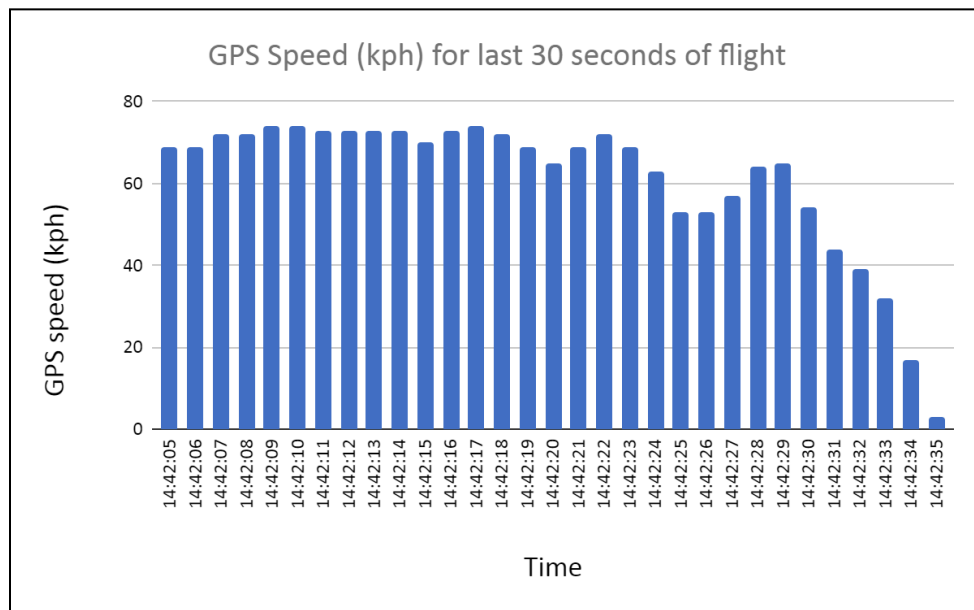
- 1.10.1.4. Analysis of GPS Speed **for the last 30 seconds of flight. Speeds in excess of 70kph are regularly recorded.** Sharp drop off in speed to point of accident. NB. Each column on the graph represents one second.

**Figure 19:** Tracklog derives GPS speed for the last 30 seconds of flight

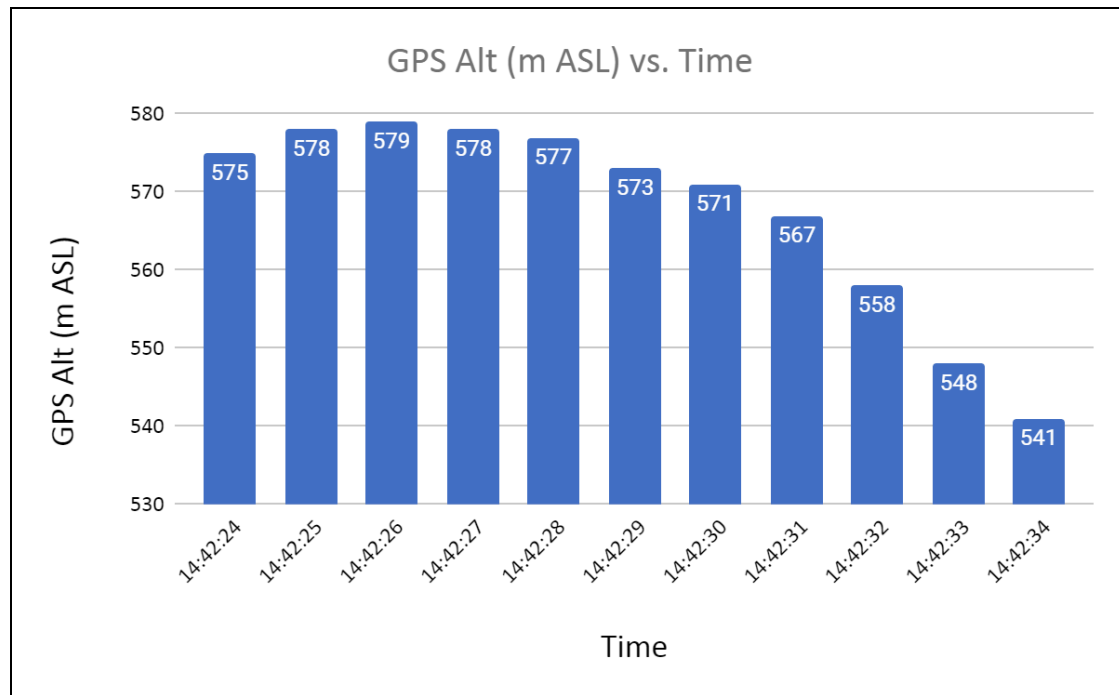
- 1.10.1.5. Analysis of GPS altitude for the last 10 seconds of flight. The typical descent rate of a paraglider is 1m/s in still air. Paragliding rescue parachutes are tested to withstand landings of 5.5m/s. In the last 3 seconds before coming to a stop, the glider descended from an altitude of 567m to 541m. This equates to a drop of 26m over 3 seconds or an average descent of 8.7m/s. This is a **significantly high descent rate**. It also implies that the **pilot was relatively close to the terrain** when an occurrence caused the rapid loss of height which resulted in the accident.

**Figure 20:** Tracklog derives GPS altitude for the last 10 seconds of flight. Rapid loss of altitude starts from 567m ASL. The accident occurred at 541m ASL.

Given the significant loss of height (ASL) in the last few seconds of the flight is reasonable to conclude that a turbulence-related event caused a lack of control ultimately ending up with the pilot impacting the mountain whilst still in a flying position. It is likely that the pilot

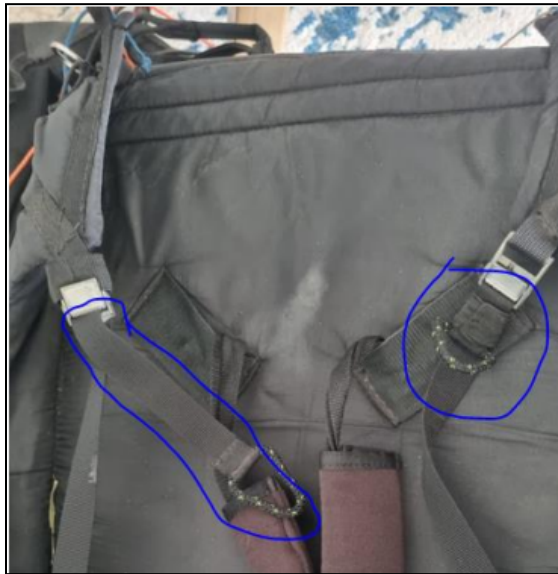
Figure 22: Harness setup showing leg straps asymmetry

- 1.15.1. A full post-accident inspection of the pilot's equipment was commissioned by SAHPA. An independent paragliding service centre performed the inspection. The following are the key findings from this report
- 1.15.2. Post-accident inspection report key findings:
  - 1.15.2.1. Harness Inspection: Cleats holding the front of the seat board in place were set up asymmetrically

2.4.1. The pilot's harness was set up asymmetrically - this could have had a negative impact on his control of the craft when he encountered turbulence. However, it should be noted that it is unknown whether the asymmetrical setup was changed during or after the accident.

- 4.4.1. It is recommended that SAHPA educate its pilots on the basics of equipment maintenance including the dangers of asymmetrical setups.

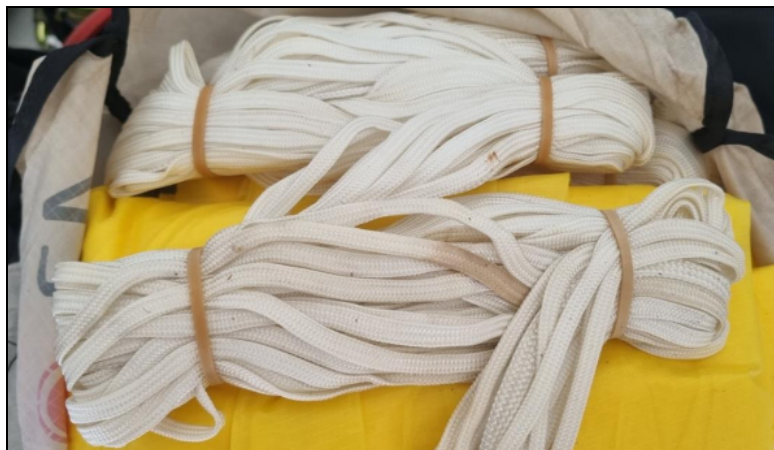
Figure 23: Rescue parachute lines

- 1.15.2.2. Rescue parachute inspection
  - 1.15.2.2.1. Rescue parachute: The Gin One G was found to be in serviceable condition, with relatively fresh elastics holding the lines together:

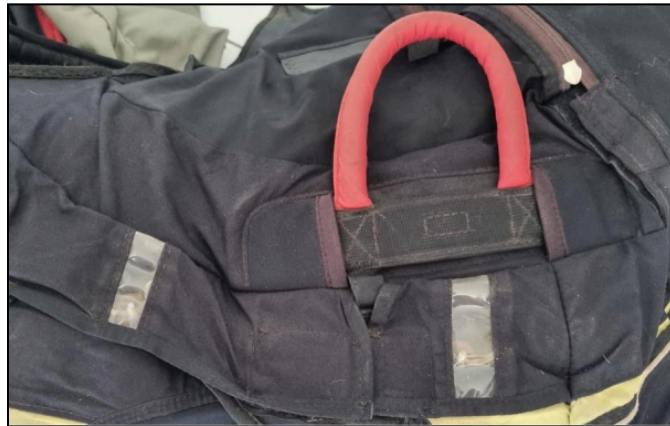
Figure 24: Rescue handle in position

- 1.15.2.2.2. Rescue handle: The Rescue handle pins were found to be in position on the harness, with the Rescue parachute requiring no more than 650g force to extract the Rescue from the container

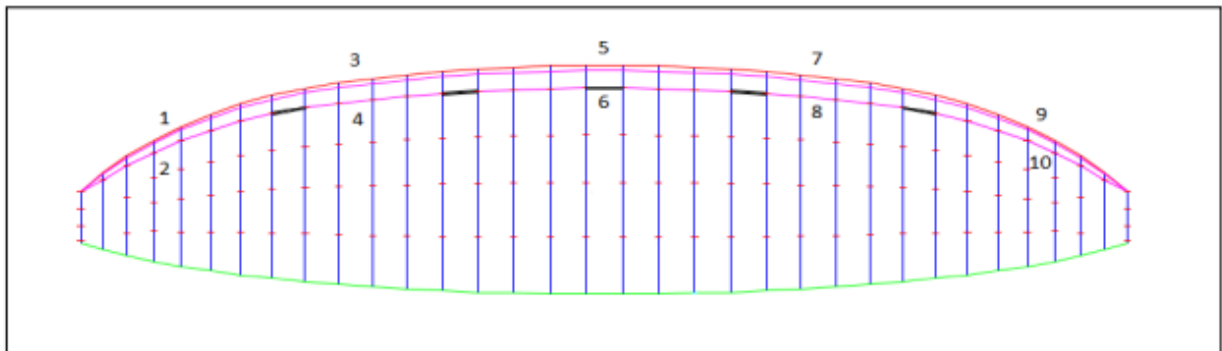
Figure 25: Porosity test locations

- 1.15.2.3.6. Fabric porosity tests: **the top surface fails due to the reading at one of the locations being <19 seconds**. The bottom surface was not measurable, as the air passed through the porosity meter faster than the meter could be set up indicating that the fabric on the bottom surface is completely porous.

<b>1</b>	<b>3</b>	<b>5</b>	<b>7</b>	<b>9</b>	
<b>45.1</b>	<b>27.7</b>	<b>24.8</b>	<b>44.9</b>	<b>17.7</b>	<b>sec</b>
<b>2</b>	<b>4</b>	<b>6</b>	<b>8</b>	<b>10</b>	
<b>0.2</b>	<b>0.2</b>	<b>0.2</b>	<b>0.2</b>	<b>0.2</b>	<b>sec</b>

**Figure 26: Porosity test values**

2.4.3. The post-accident service report indicates that the porosity of the glider failed due to the 17.7 seconds porosity reading on the top right surface of the wing. **However, comments received from the manufacturer indicate that the porosity is unlikely to be a significant contributing factor to the accident.**

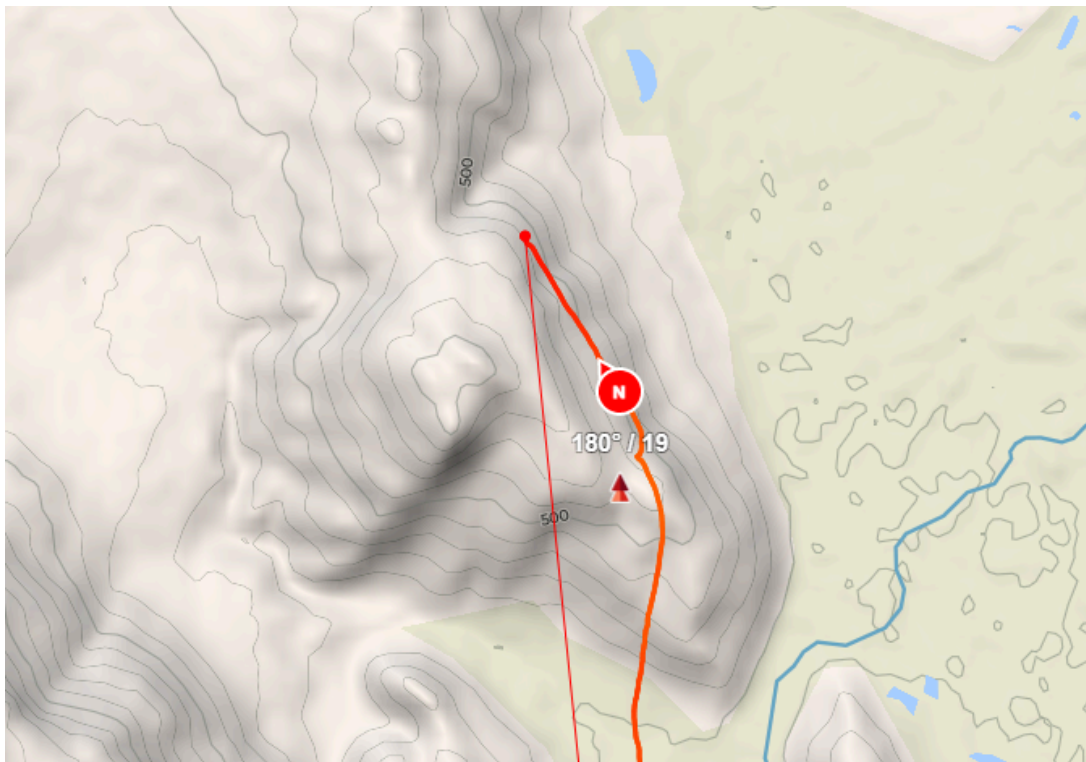
- 2.2.1. Analysis of the forecasts, the actuals from the Worcester AWS, witness statements and the GPS speeds from the pilot all point to strong wind at the accident location.
- 2.2.2. Wind direction forecast for the area of the accident, as well as that derived from the pilot's flight app on his mobile device, indicate a southerly wind direction (180 deg, 19 kph)

**Figure 28:** Screenshot of tracklog showing topography and wind calculations derived from the IGC tracklog (analysed using SeeYou software). Map orientation north facing up.

Analysing the wind speed, direction and topography of the terrain it is **quite likely that the main cause of the accident was the rotor (mechanical turbulence)** created from the southern end of the mountain flowing down the northeast-facing ridge on which the accident occurred.

- 4.3.1. It is recommended that SAHPA remind pilots of the dangers of flying in strong wind. These dangers include both the immediate danger of rotor turbulence, as well as possible delays of medical assistance due to inclement weather hindering rescue efforts, especially in difficult-to-access terrain.
