Preliminary Accident Report

Version number: 1.1
Date 10 December 2024

By Ria Moothilal on behalf of SAHPA / SACAA

Reference Number: SAHPA/128/25/03/2024

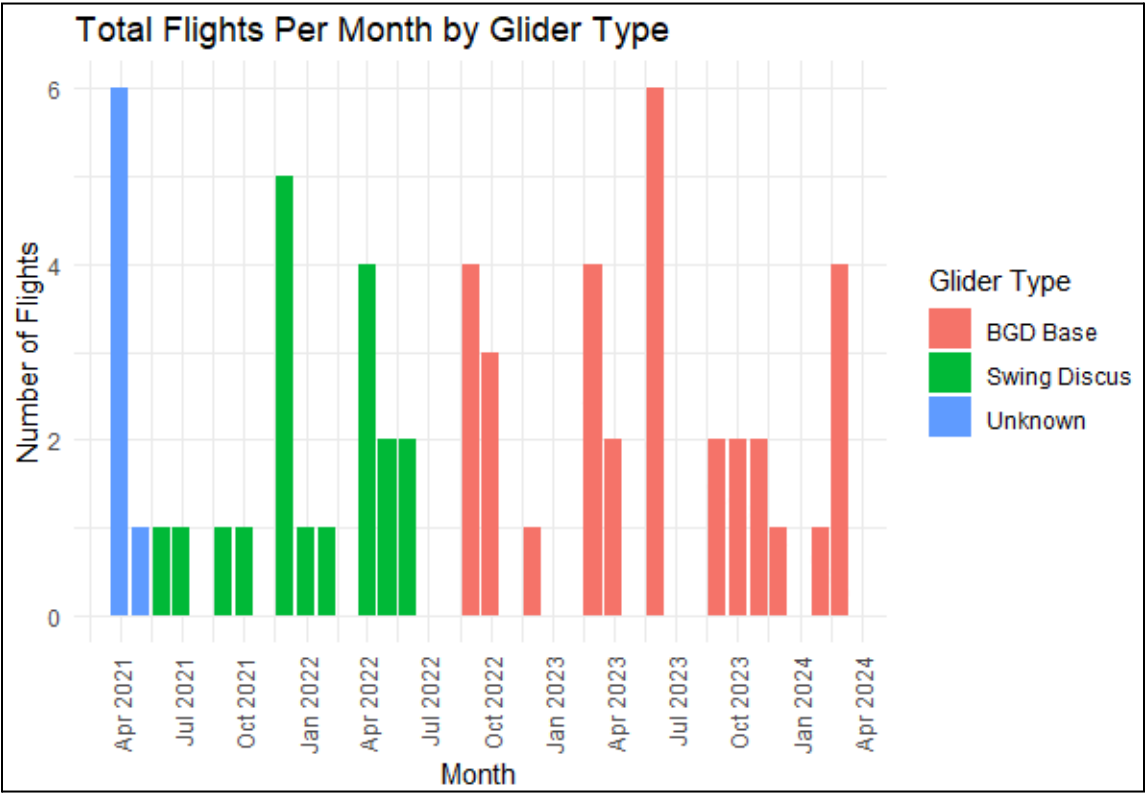
- 1.4.5. The pilot's electronic logbook shows a relatively low number of flights per month with some months not flying at all. It also shows that he changed from a Swing Discus (EN A) glider to a BGD Base (EN B) in September 2022

Figure 4: Monthly flights over time by glider type

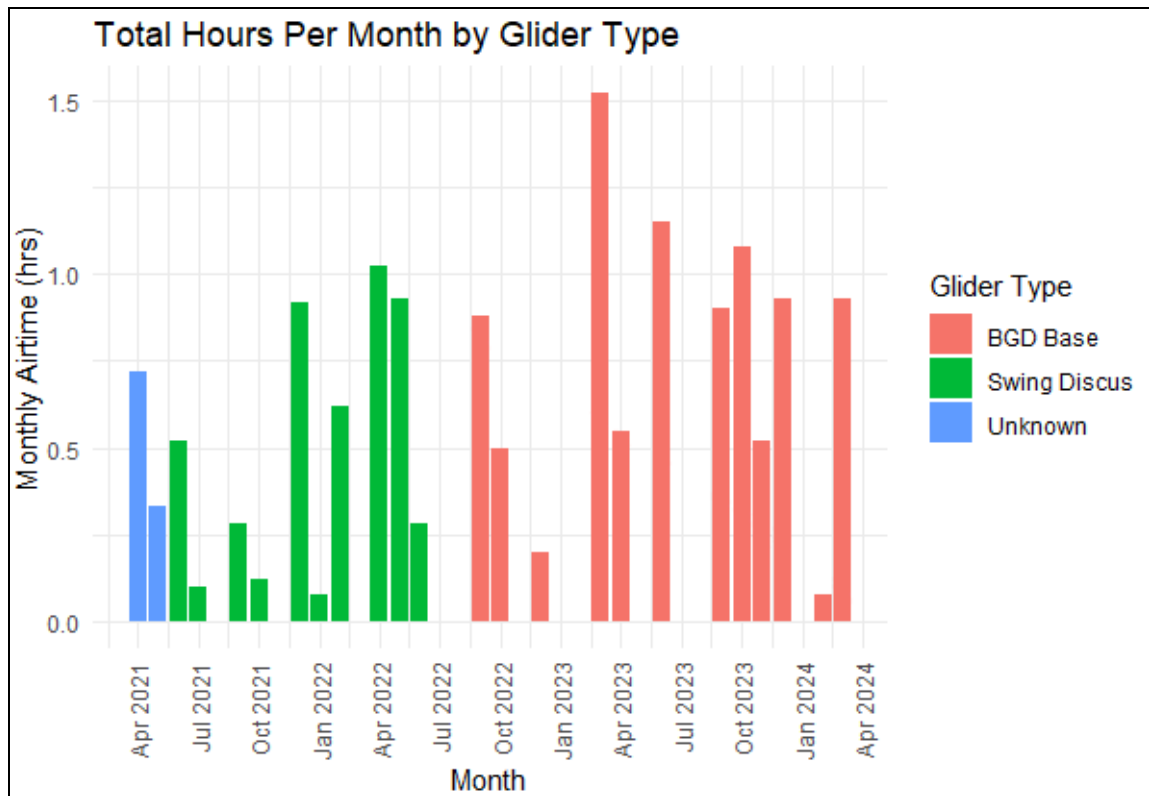
- 1.4.6. From the available electronic logbook, the pilot often flew less than one hour per month

Figure 5: Monthly hours over time by glider type

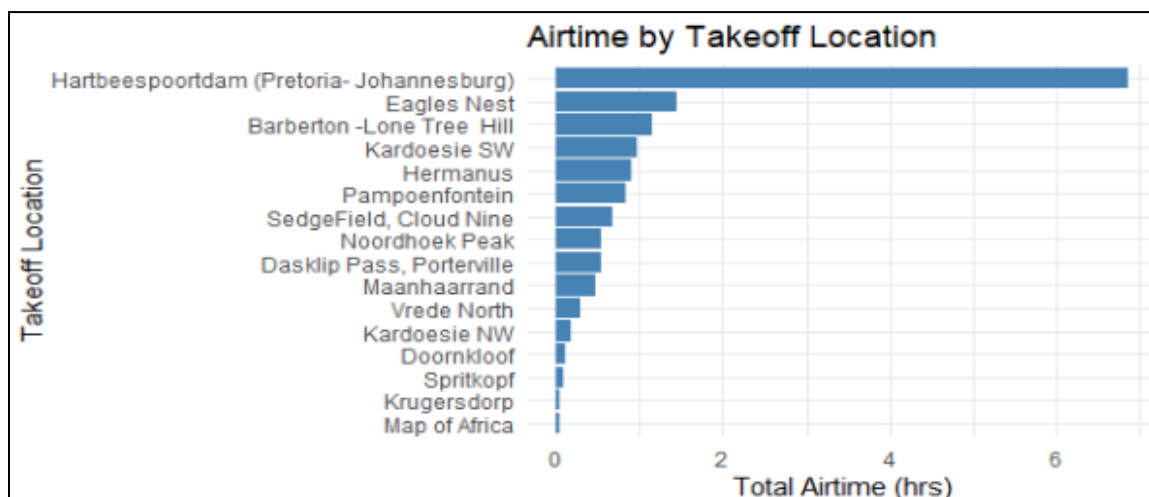
1.4.7. The majority of the pilots' flying experience in the previous 3 years was at inland mountain sites

Figure 6: Takeoff Site Experience

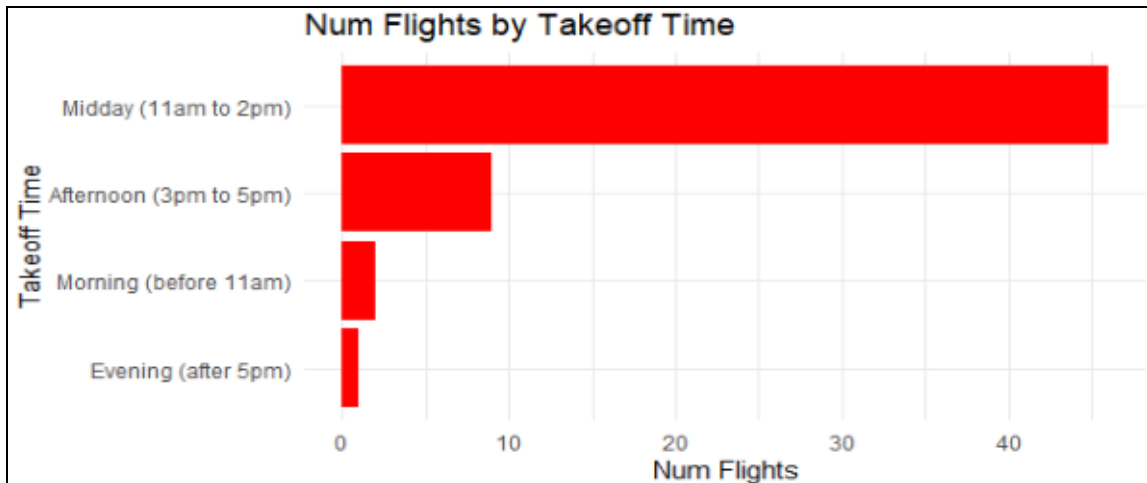
1.4.8. The majority of the pilot's flights started in the middle of the day i.e. peak thermal activity

Figure 7: Take off time of day analysis

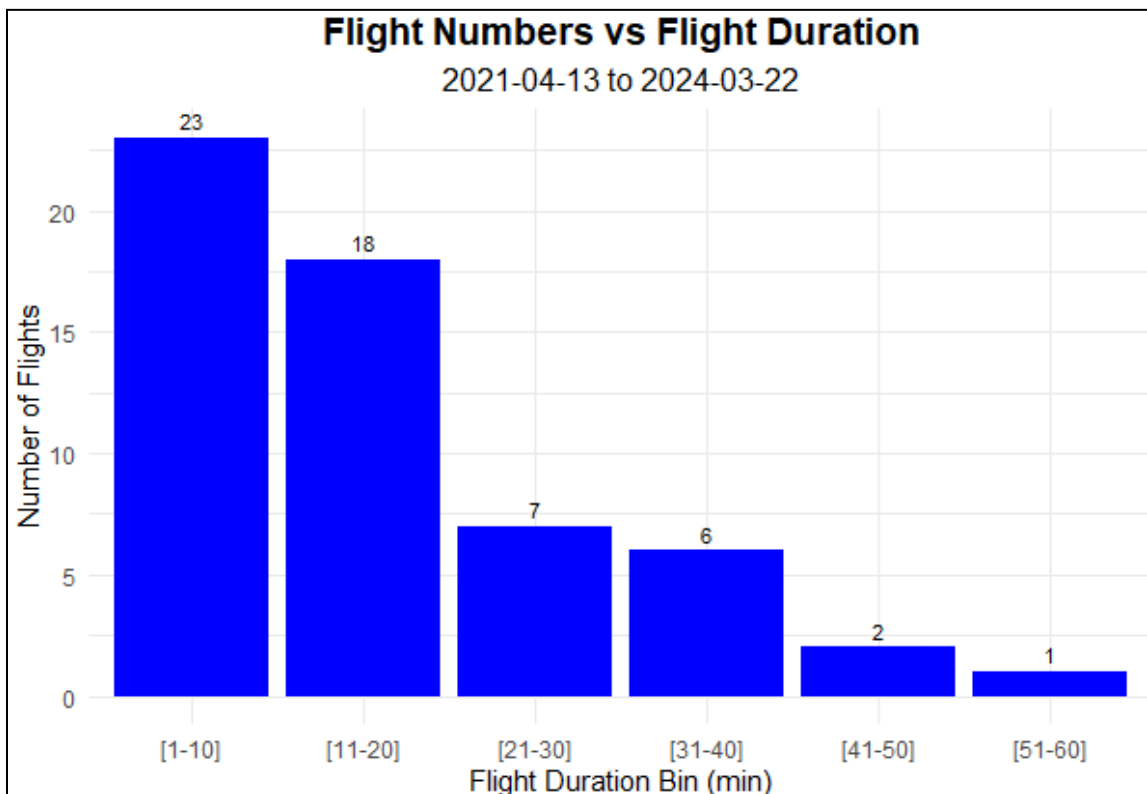
1.4.9. The majority of the pilot's flights were relatively short. In the past 3 years, only 3 flights were longer than 40 minutes with the maximum duration on record being a single flight of 56 minutes.

Figure 8: Duration of flight analysis

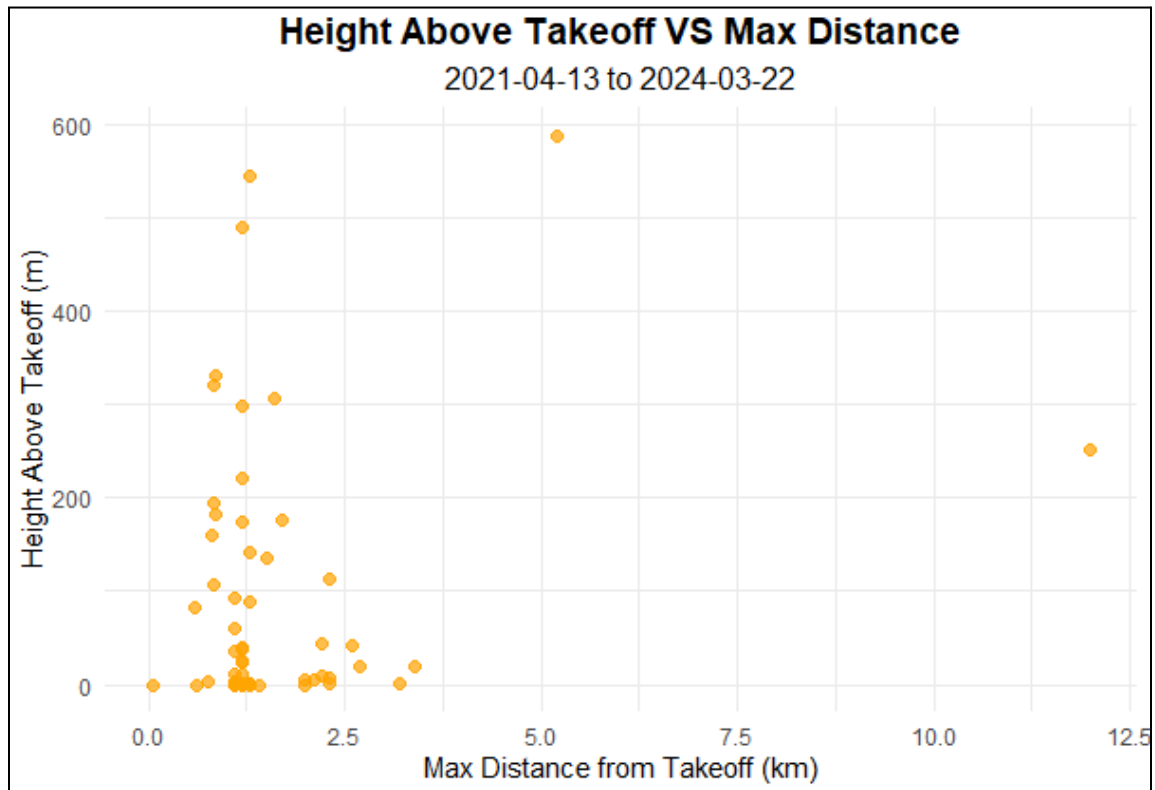
- 1.4.10. The majority of the pilot's flights in the past 3 years were flights that were relatively short in distance from takeoff (xc distance) with a maximum of 12km on record. 75% of flight distances in the last 3 were less than 1.7km from takeoff. Height gains above takeoff are also relatively low compared to that achievable on a paraglider. 75% of flights showed height gains of no more than 140m above takeoff altitude, and 50% of flights showed height gains less than 20m above takeoff altitude.

Figure 9: Flight characteristics analysis

- 2.3.4. Thermal flying experience - analysis of the pilot's takeoff locations shows that he was familiar with inland mountain flying conditions. However, analysis of flight duration, altitude gains, and distance from takeoff speak to short flights with limited thermal experience. This infers limited turbulence control experience.

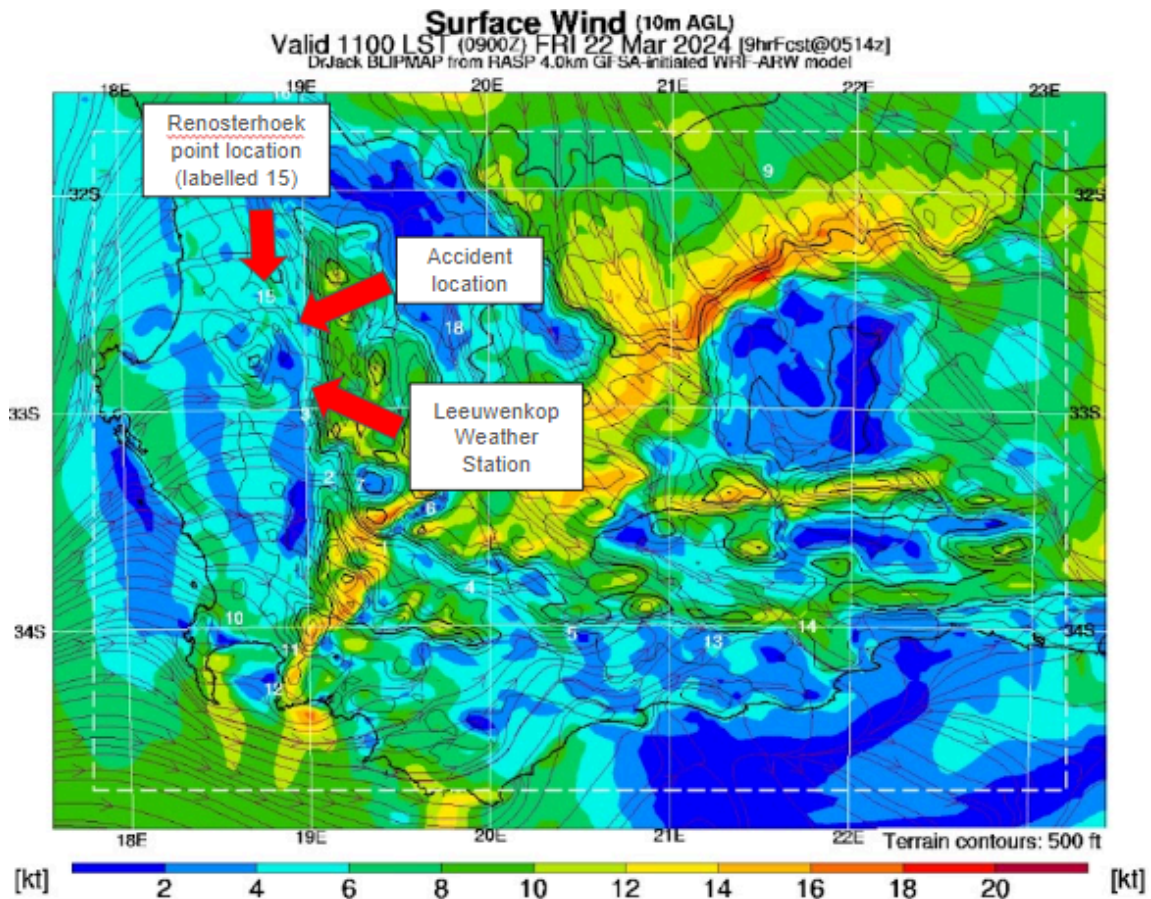
Figure 13: RASP 11 am Surface wind forecast. Map orientation north facing up.

- The surface wind forecast for the accident site is up to 6 kts (11kph) north-west
- The surface wind forecast for the Leeuwenkop weather station (the closest available weather station with live readings) is similar at 6kts (11kph)

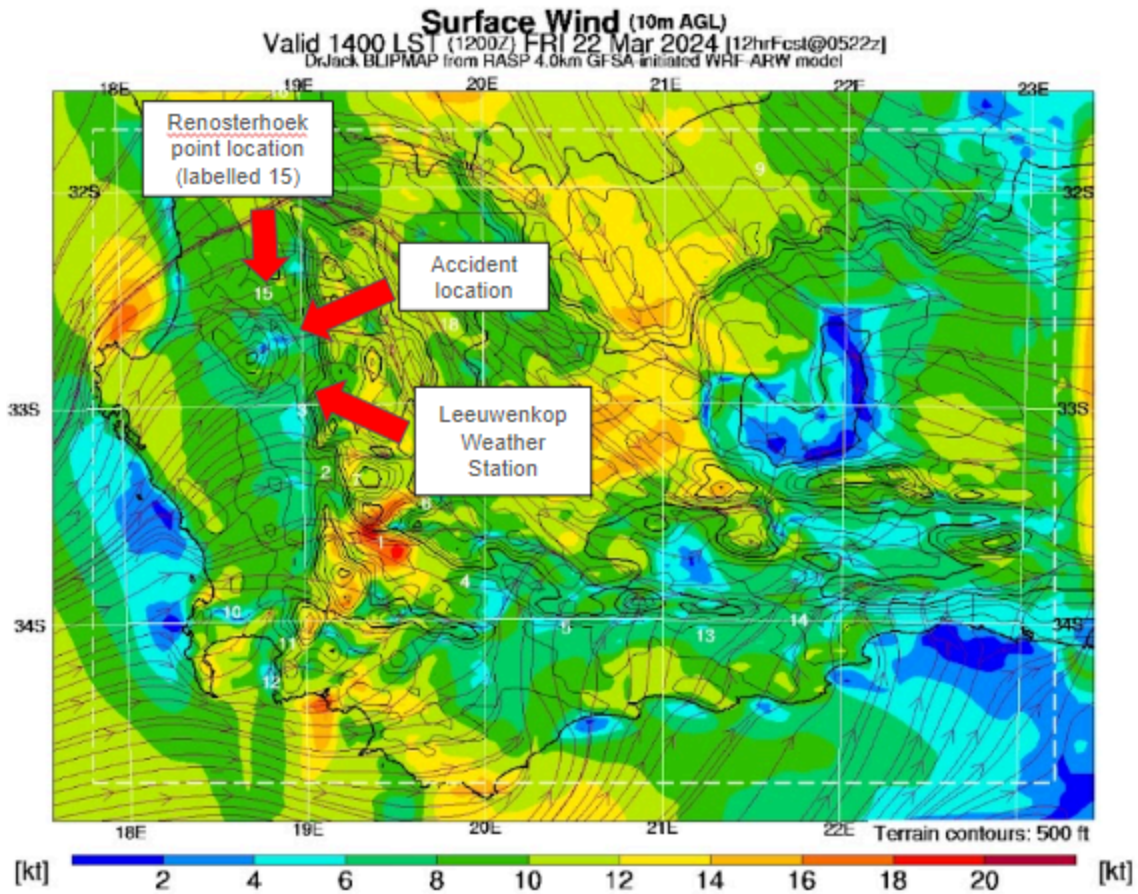
Figure 14: RASP 2 PM Surface wind forecast. Map orientation north facing up.

- Surface wind speed forecast for the accident site is around 8kts to 10kts (15 to 19kph) west
- The surface wind forecast for the Leeuwenkop weather station (the closest available weather station with live readings) is around 8kts to 10kts (15 to 19kph) south-west

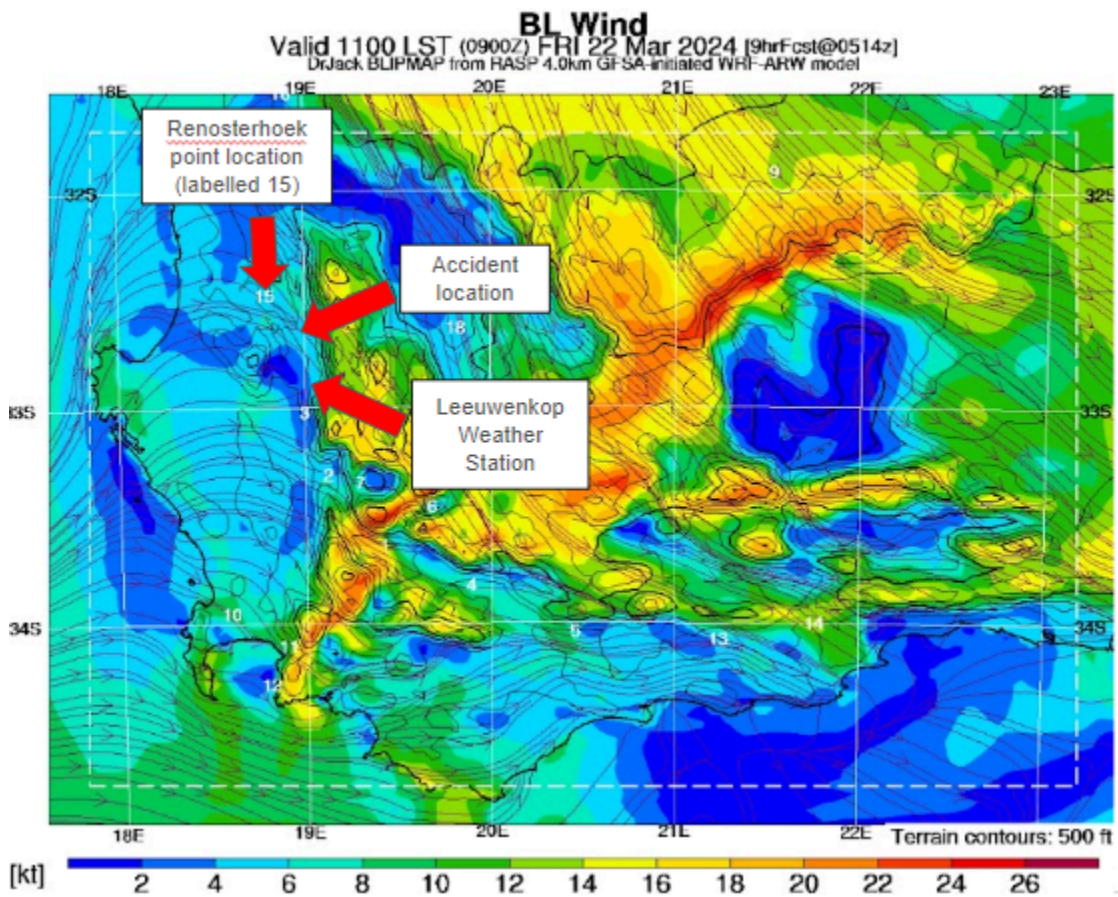
Figure 15: RASP 11 AM boundary layer average wind forecast. Map orientation north facing up.

- The boundary layer is the layer of air in which thermals from the ground level rise. The type of paragliding flight used in the case of this accident was that of thermal flying. The forecast average boundary layer wind gives an idea of the average wind speed above ground level and within which this paragliding flight would have taken place.
- The boundary layer average wind speed forecast for the accident scene is up to 6kts (11kph) WNW
- The boundary layer average forecast for Leeuwenkop weather station is similar at up to 6kts (11kph) direction WSW.
- The Boundary Layer average wind speeds are similar to the surface winds indicating that there's a negligible increase in wind speed with altitude from ground level below thermal top altitude

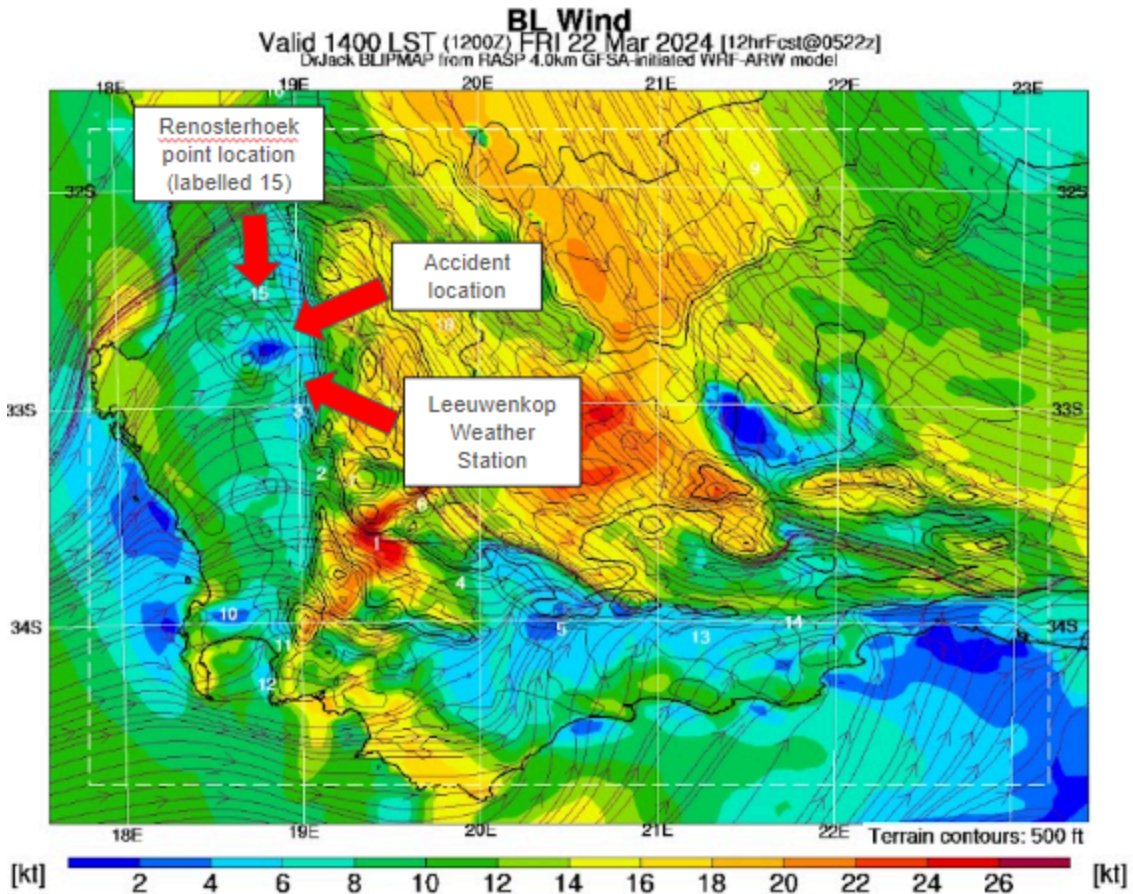
Figure 16: RASP 2 PM boundary layer average wind forecast. Map orientation north facing up.

- The boundary layer average wind speed forecast for the accident scene is around 8kts (15kph) W
- The boundary layer average forecast for Leuwenkop weather station is similar at around 8kts (15kph) from the direction WSW.

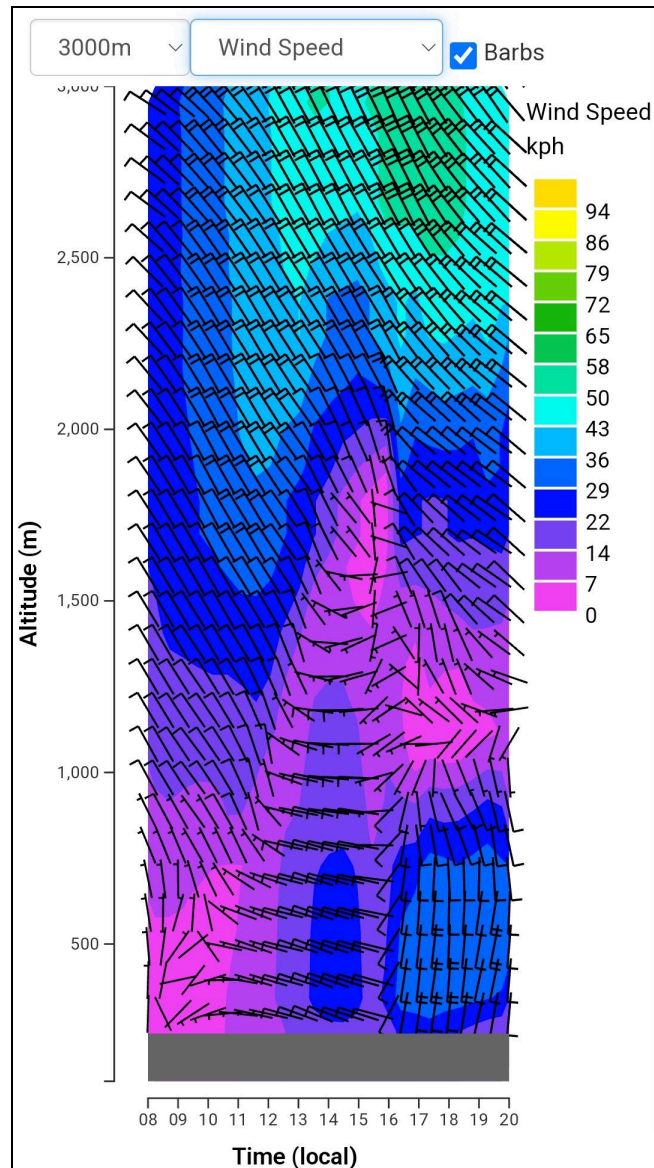
Figure 17: SkySight weather model wind forecast by altitude and time of day.

From the above graph, we can see that this weather model forecasts as WNW wind direction with the wind speed in the 14kph to 22kph range around 1 pm (the time of the accident). The forecast also shows an increase in wind speed around 13h30 to 15h00 before dropping off again and then increasing significantly from a southerly direction in the evening.

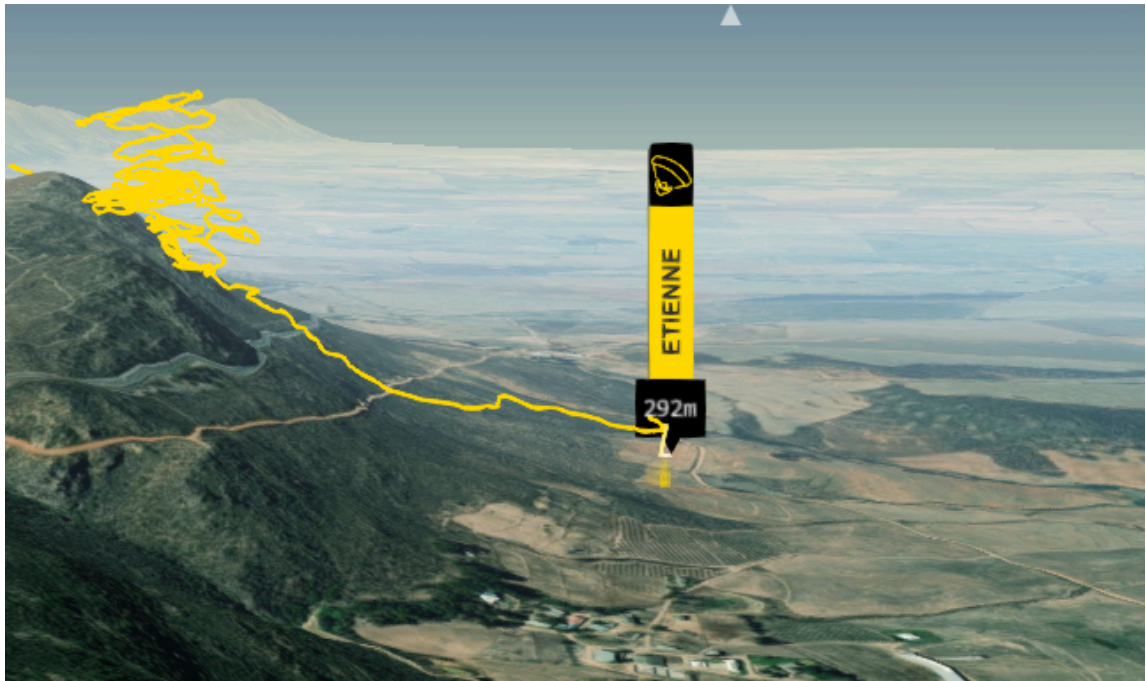
- 1.10.1.2. 3D Views show the pilot flying along the ridge on which the accident occurred. NB. The track overlay against the image topography is not perfectly aligned, i.e., the track is displayed higher than the actual ground level, as evident from the endpoint floating above the imagery ground level.

Figure 22: Side view leading down to the accident site.

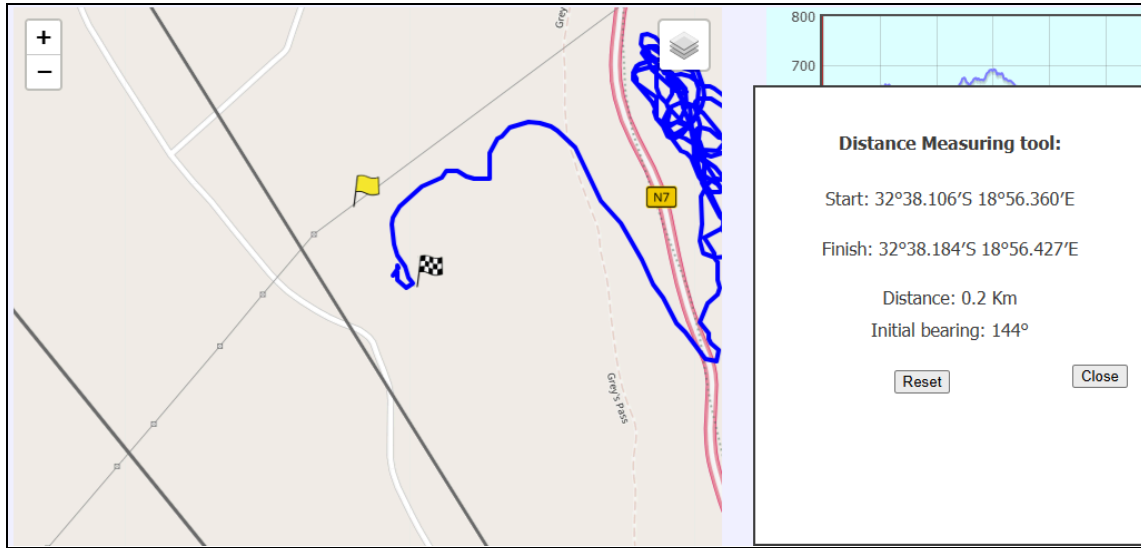
- 1.11.1. Location of the accident: 32°38'10.4"S 18°56'24.4"E
- 1.11.2. The terrain is on the lower slope of a mountain on a farm field.
- 1.11.3. Located west of Piekinierskloof Pass on the N7 highway.
- 1.11.4. Witness statements indicate that the pilot was found with a weak pulse, unconscious, with significant blood loss.
- 1.11.5. Power lines in the vicinity, ~200m away from the accident site at its closest point

Figure 27: Accident location including power-line proximity (~200m between flags diagram). Map orientation with north facing up.
