# Preliminary Accident Report

Date 29 July 2023

By Ria Moothilal on behalf of SAHPA / SACAA

**Reference Number:** SAHPA/103/04/04/2023

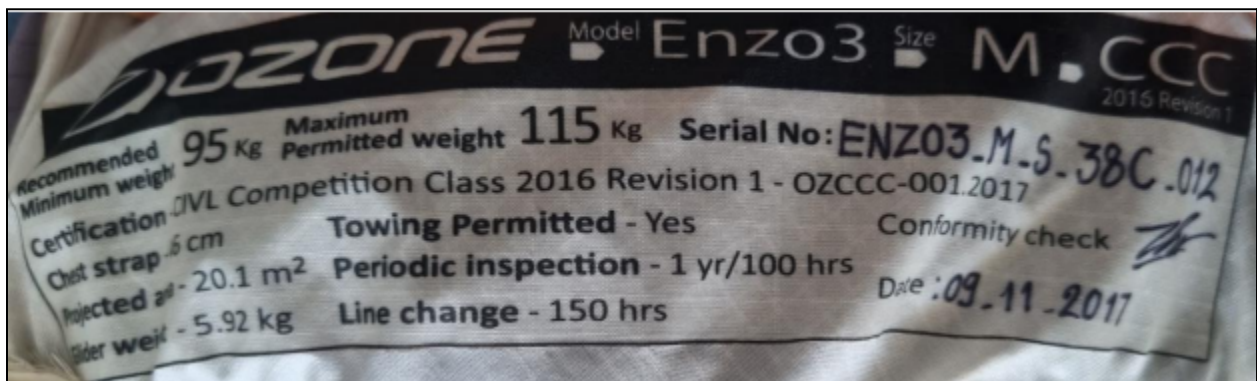
**Figure 5:** Paragliding wing nameplate

- 1.15.2.3. Wing inspection:
- 1.15.2.3.1. Visual inspection shows that the fabric was severely discoloured
  - 1.15.2.3.2. The condition of the lines was found to be visually in average condition

- 1.15.2.3.6. Fabric porosity tests: **the top surface fails due to the reading at one of the locations being <19 seconds**. The bottom surface was not measurable, as the air passed through the porosity meter faster than the meter could be set up indicating that the fabric on the bottom surface is completely porous.

- 1.15.2.3.7. Fabric strength tests performed on the wing failed on the first test in the weave direction so no second tests in the weft direction were done.

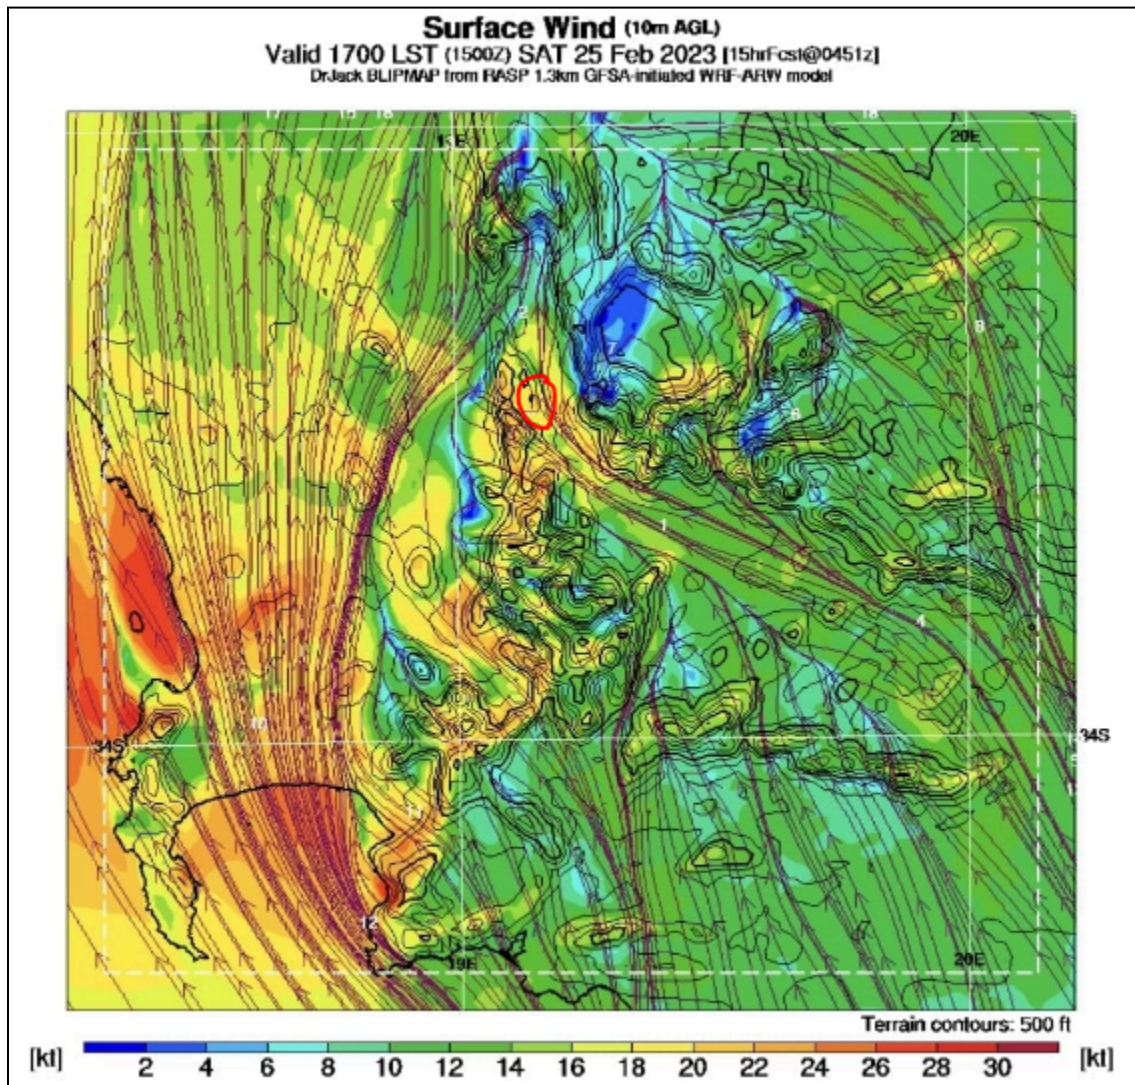
**Figure 9:** RASP 5 pm Surface wind forecast. Map orientation north facing up. The accident location is circled in red.

- 1) Surface wind speed forecast for Worcester (labelled 1 in the RASP diagram) is ~14kts (26kph)
- 2) Surface wind forecast for the accident site (circled in red) is ~ 20kts (37kph)
- 3) A southeast wind flowing through the Worcester valley was forecast to turn into southerly wind direction in the valley where the accident occurred.

Analysing the wind speed, direction and topography of the terrain it is **quite likely that the main cause of the accident was the rotor (mechanical turbulence)** created from the southern end of the mountain flowing down the northeast-facing ridge on which the accident occurred.

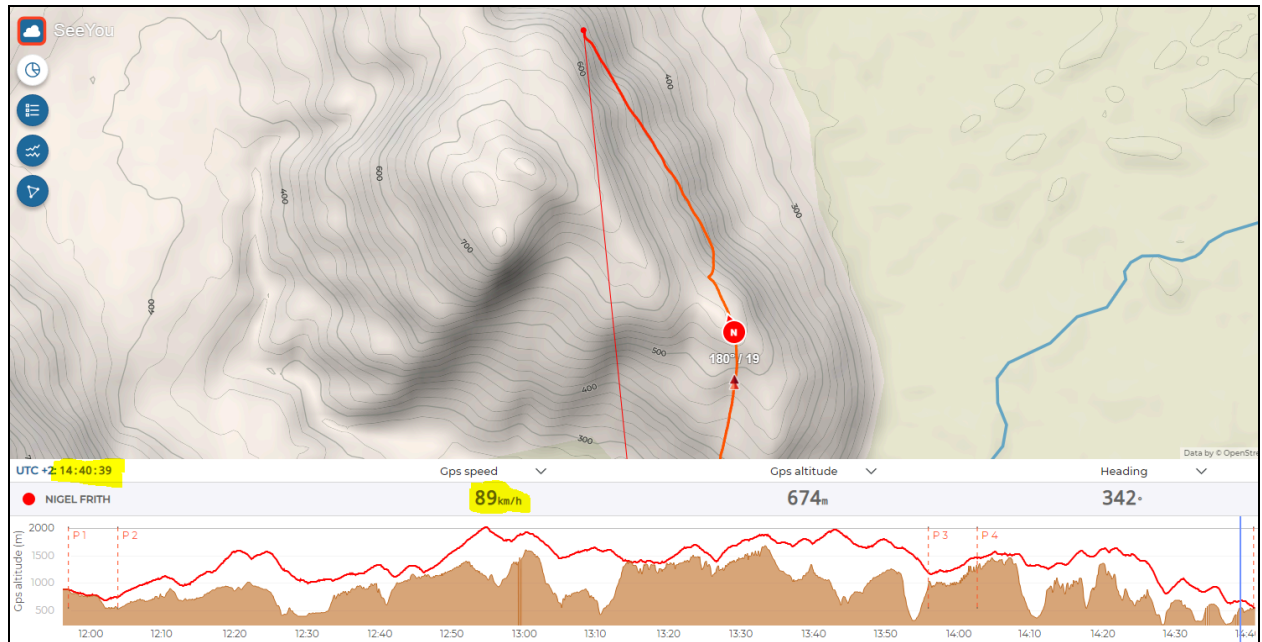
- 1.10.1.2. 2D View showing the last section of the flight. At 14:40:39 a GPS Speed of 89kph was recorded at 14h40 i.e. two minutes before the accident. It also shows that the pilot flew on NNW heading following the contour of the ridge. **The accident occurred on the downwind side of the ridge if the wind was coming from the south.**

**Figure 17:** Final section of the flight leading to the accident. Map orientation north facing up.

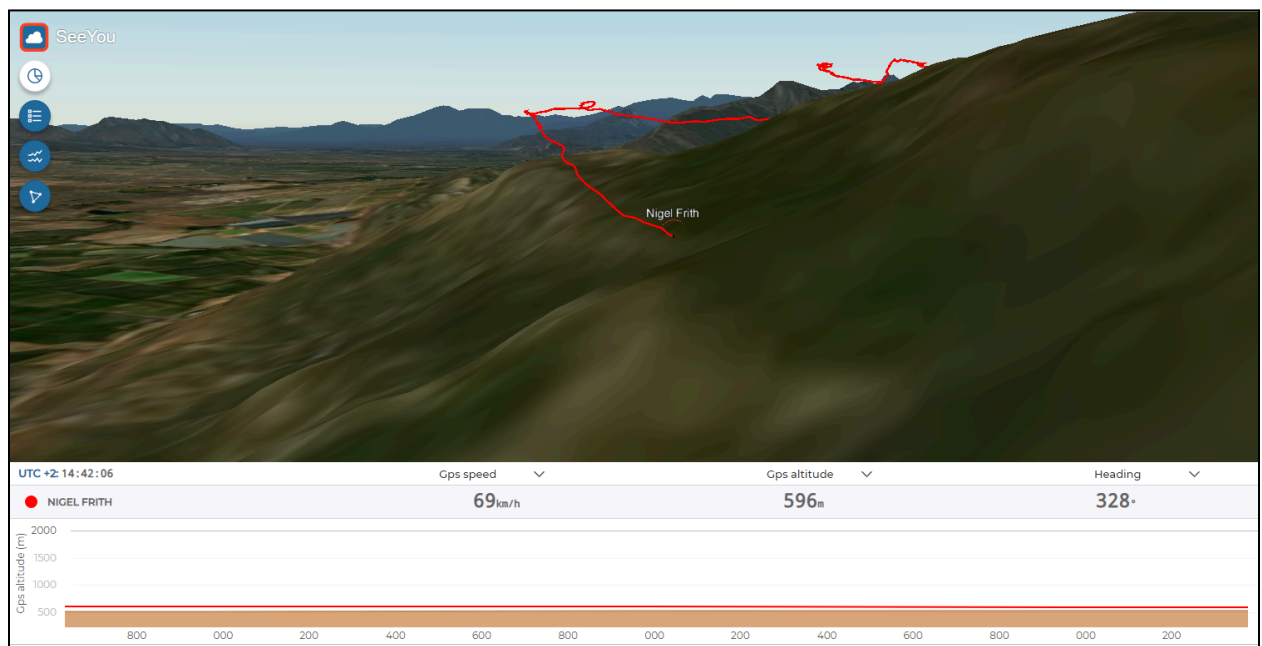
- 1.10.1.3. 3D View showing the pilot flying along the ridge on which the accident took place. The snapshot is taken at 14:42:06, almost 30 seconds before the accident. The view shows that the pilot arrived at the corner of the ridge and then turned to follow a NNW heading along the contour of the ridge. It can be seen that the pilot was descending as he flew along the ridge.

**Figure 18:** 3D view showing the flight path taken at ~30 seconds prior to the accident

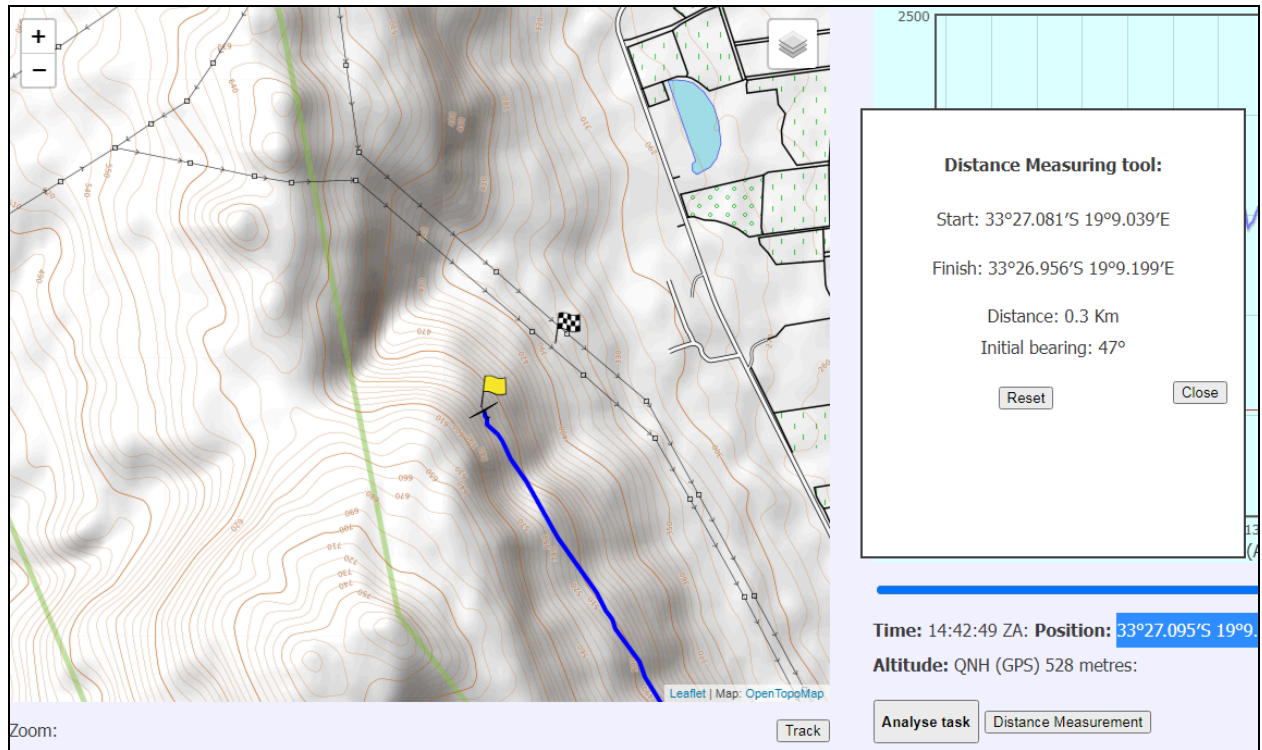
- 1.11.1. Location of the accident: 33°27.095'S 19°9.047'E
- 1.11.2. The terrain is mountainous and covered in fynbos with no easy access
- 1.11.3. Located west of farmhouses below
- 1.11.4. Witness statements indicate that the pilot was found lying unconscious on his left side with his head higher than his feet, facing in a northerly direction. There were no signs of bleeding and no broken bushes in the area.
- 1.11.5. Power lines in the vicinity, 300m away from the accident site at its closest point

**Figure 21: Accident location including power-line proximity (300m between flags diagram). Map orientation with north facing up.**
